Laser Cutting system QuikLaze-II 40Hz Green/UV (532nm/355nm)

Manufacturer: New Wave Research Inc., USA

This system consisting of the laser head mounted on top of the Mitutoyo FS-60 microscope and laser control unit with remote control (picture 1) was received on loan for my hardware security research in April 2003. Unfortunately, as it always happens, this equipment was out of good working order and therefore could not be used straight away for my research. Firstly, the whole system was misaligned resulting in cuts too far away from the desired rectangular shape. Secondly, the laser head behaved strangely, sometimes placing the filter revolver in a slightly wrong position out of the laser beam and, moreover, sometimes changing all servo settings spontaneously to a random position. Also the optics inside the laser head and the microscope was a bit dusty.

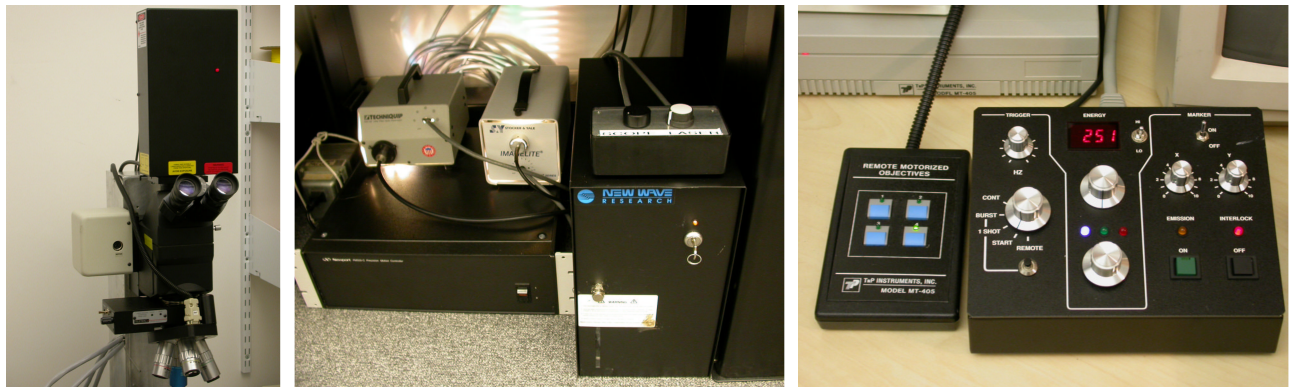
Picture 1. The laser cutting system: a) laser head and microscope; b) control block and illuminators; c) remote controls

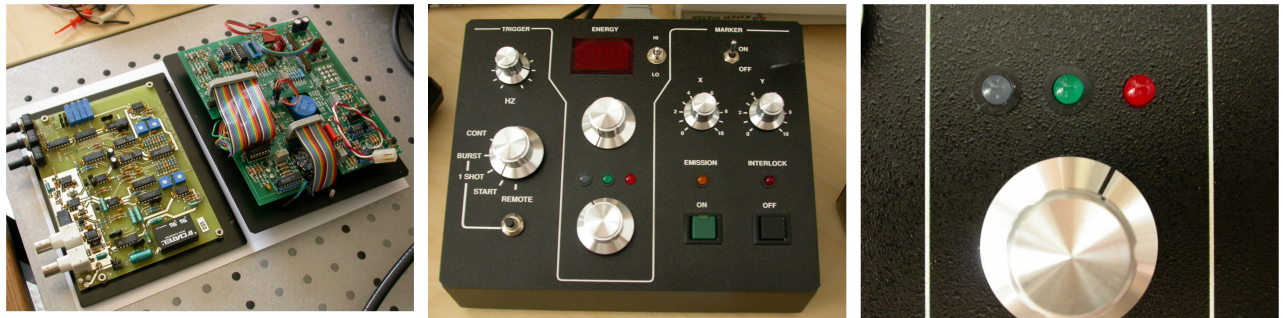
Picture 8. Upgrading the remote control: a) inside view; b) front view; c) close look

What has been done so far is that the remote control unit was upgraded to support three wavelengths (picture 8). For this the third position of the laser switch was unlocked, a hole was drilled in the front panel and a red LED installed in it.
